# Case Study

## SLOPE STABILIZATION: APARTMENT COMPLEX EROSION THREAT

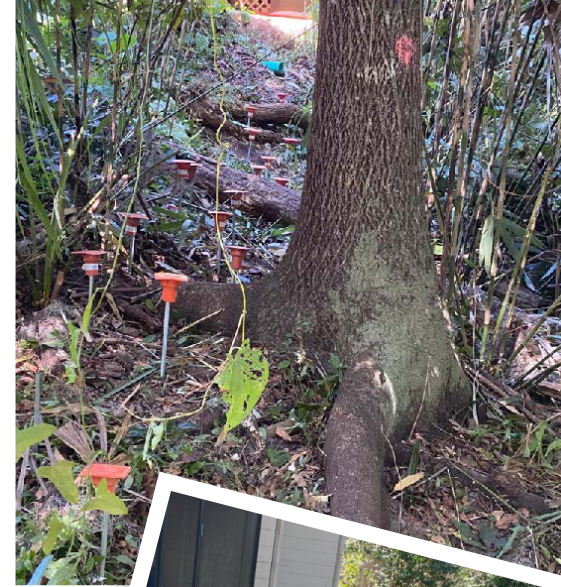
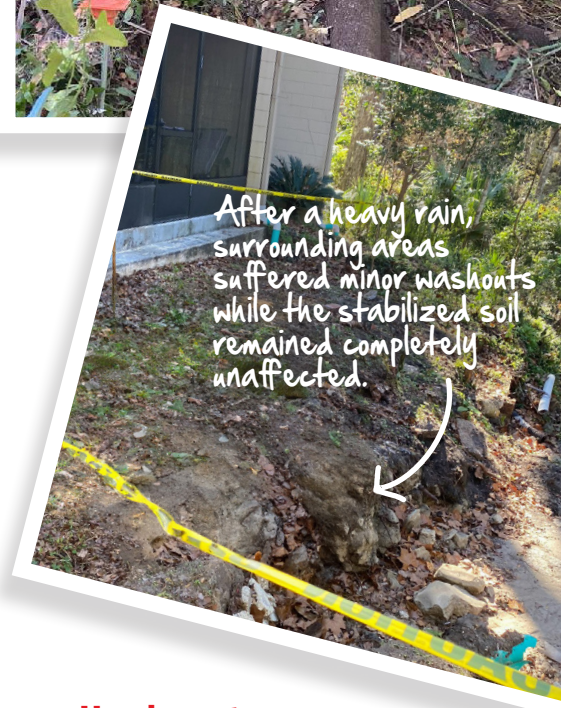
After a heavy rain, surrounding areas suffered minor washouts while the stabilized soil remained completely unaffected.

Injection points were established in a zigzag pattern, spaced 18 inches apart. The team drilled 10 feet below grade to reach the optimal depth for soil reinforcement. Low-pressure injection was key to the operation's success. This approach prevented the chemical from fracturing the soil or moving in unintended directions. The injection rod was slowly extracted, allowing for precise distribution of the polymer. One gallon was applied every five minutes and every vertical foot. In total, a 240-foot row of soil stabilization resin was installed.

The impact of this intervention was immediately apparent. During a subsequent heavy rain event, surrounding areas suffered minor washouts while the stabilized soil remained completely unaffected. The stark contrast in performance served as a powerful testament to the effectiveness of the AP Soil 600 polymer and the precision of its application. The apartment buildings, once precariously positioned near the eroding embankment, now stand secure and protected, their foundations no longer at risk from the relentless forces of erosion.
