CASE STUDY
SOIL STABILIZATION
SLAB LIFTING

Case Study - Solar Field Soil Stabilization

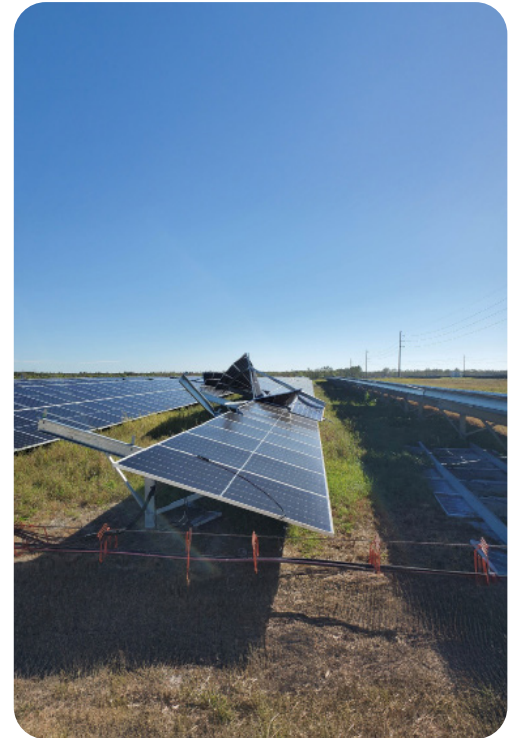
For this project, the owners wanted to get engineers involved in the grouting portion of the installation. Mathers Engineering was in charge, and they contracted Madrid Engineering to handle the soil testing. Testing showed that there were layers of clay and sand (referred to as zebra striping), so the grout was targeted in the sandy areas. The thought was that the permeated sand would be locked in between layers of clay, thus improving both compression and pull strength.

For this installation, the same three different volumes of AP Soil 600 were tested. Once again, only 3/4 of a gallon was deemed sufficient to pass the testing, so that was what was used. 5000 piles were injected on this project, about 90% of them with AP Soil 600. There were some areas of organic soils, and for those, AP Fill 700 was injected and tested successfully. AP Fill 700 has over 30X expansion and works well at improving organic soils. The work was completed in the Spring of 2022, and the solar field went into service.
